# The 13<sup>th</sup> ISAV2023 International Conference on Acoustics and Vibration

20, 21 Dec 2023      Tehran - Iran

## Vibration Analysis for Fault Diagnosis in an Overflow Ball Mill: A Case Study at Sarcheshmeh Copper Complex

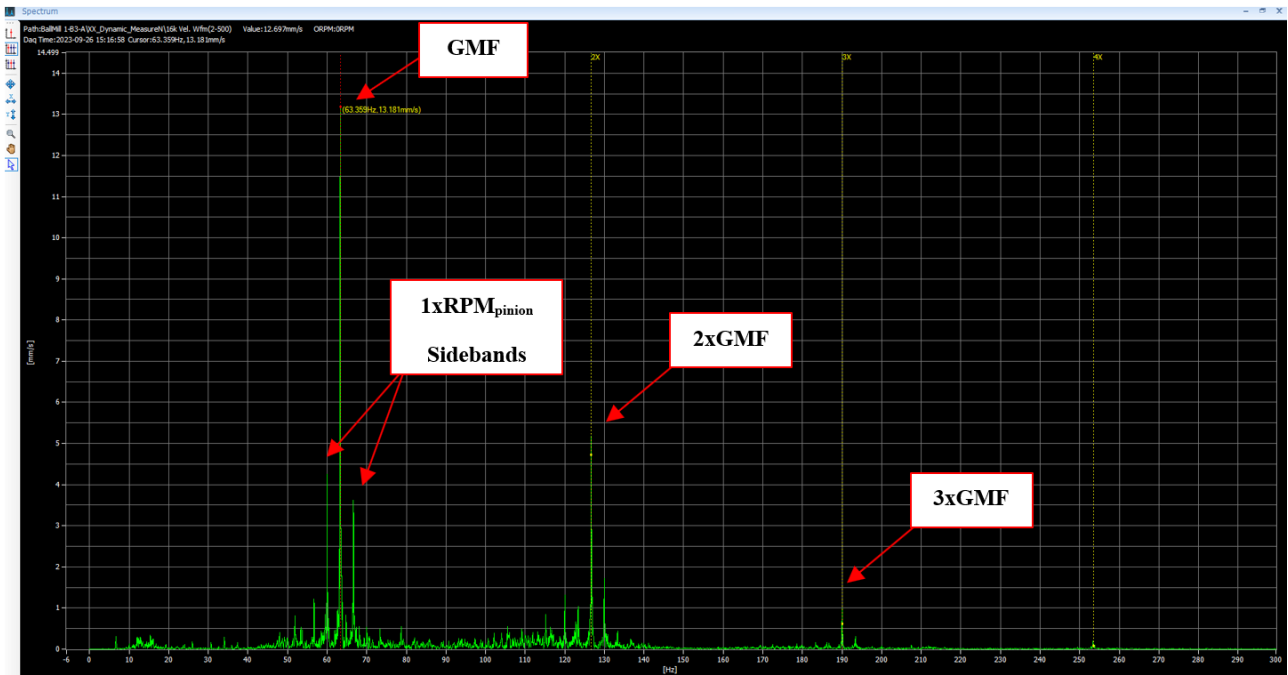
Analyzing the trend over a one-month period reveals variable amplitude vibrations observed in the axial direction of the first, third, and fourth bearings. Examining the axial direction of the frequency spectrum for bearing No.3 (see Fig. 4) and bearing No.4 (see Fig. 5) reveals that the dominant peaks are associated with gear mesh frequencies. Specifically, the 2xGMF frequency predominates in the axial direction of bearing No.4, whereas the 1xGMF frequency is the dominant peak in the axial direction of bearing No.3. Additionally, there are discernible 1xRPM and 2xRPM sidebands surrounding the 1xGMF and 2xGMF frequencies in the frequency spectrum of both bearing No.3 and No.4.

Figure 4. Bearing No.3 Frequency spectrum axial direction

Upon analyzing the frequency spectrum of the third and fourth bearings, it becomes evident that the high amplitude of vibrations can be attributed to the gear mesh frequencies. These gear mesh frequencies ( $3xGMF$ ,  $2xGMF$ ,  $GMF$ ) consistently appear in the standard frequency spectrum with minimal amplitudes. However, any increase in the amplitude of these peaks or sidebands suggests the potential presence of an issue within the gear assembly, necessitating further investigation. The spectrum analysis of the third and fourth bearings has unveiled the existence of certain defects, listed below in order of priority.

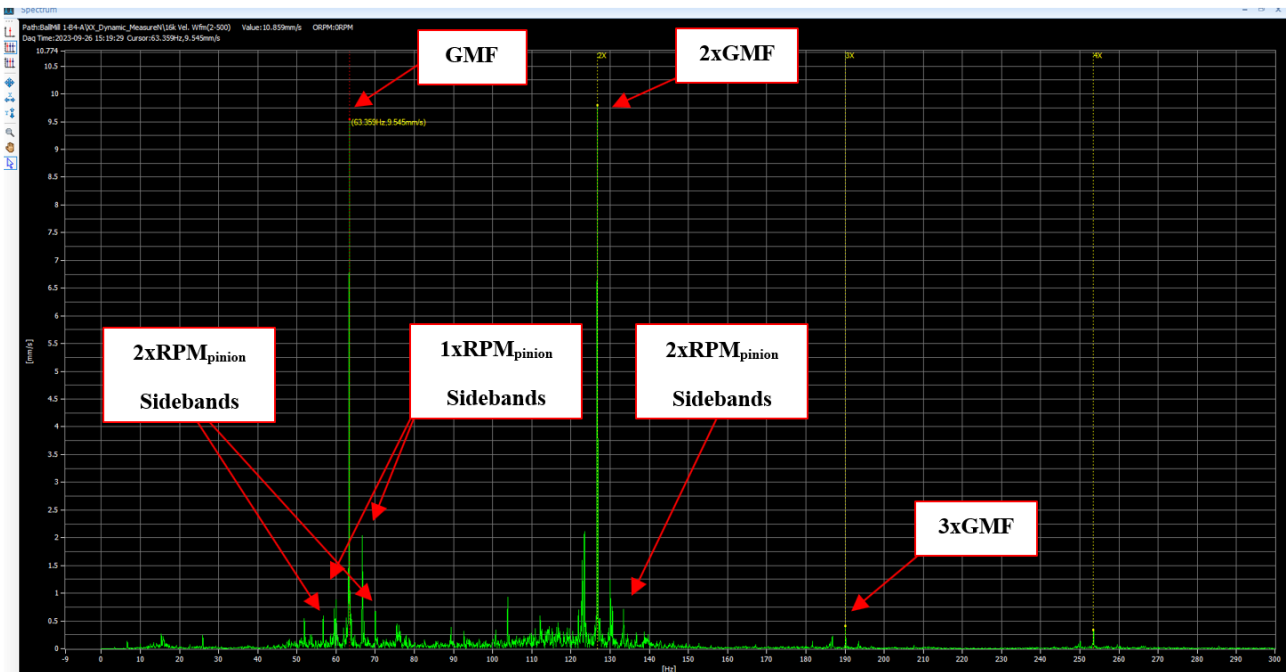
Figure 5. Bearing No.4 Frequency spectrum axial direction

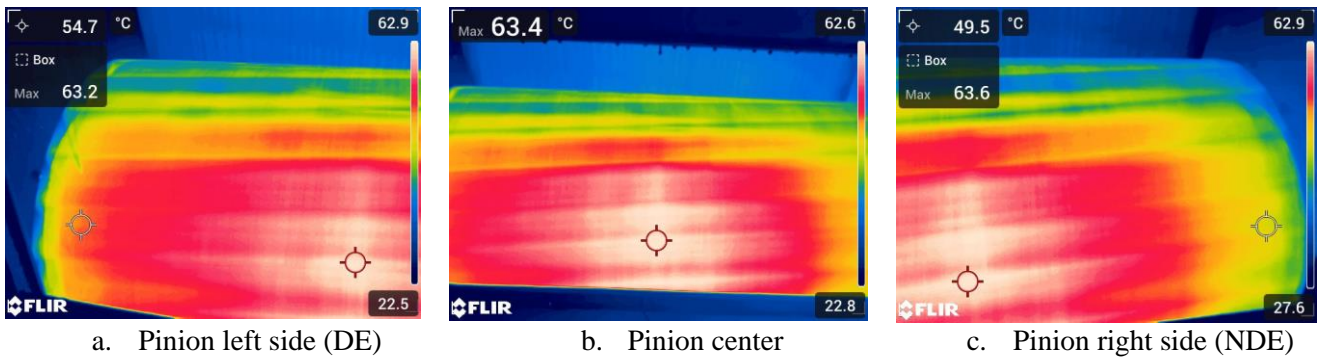
To gain a more precise understanding of the issue, temperature analysis was performed using the FLIR TG500 thermal imaging camera, and the results are illustrated in Fig 6. As evident from the illustration, the temperature distribution across the pinion's surface is uneven. The region with the highest temperature, signifying the contact surface, tilts towards the left (the drive-end side). Specifically, the temperature on the left side measures 54.7 °C, whereas on the right side, it registers at 49.5 °C.

Figure 6. Thermal analysis of pinion surface

**Misalignment:** An increase in vibration amplitude at the  $2xGMF$  frequency, along with the presence of  $1xRPM$  and  $2xRPM$  sidebands, suggests the existence of a misalignment problem within the gears. This misalignment issue is further confirmed by examining the thermography images (Figure 6). The temperature distribution across the pinion surface is non-uniform, indicating that the contact area may not be symmetrical, which is a problem resulting from misalignment. Misalignment can manifest in various forms, as illustrated in Figure 8.

The utilization of vibration and thermal analysis led to the identification of two potential faults that could impact these gear mesh frequencies: tooth profile errors and misalignment. Misalignment was indicated by an uneven wear pattern on the tooth surfaces. As a recommended course of action, it is advisable to initiate a thorough cleaning of the tooth surfaces and subject them to visual inspection. Investigating the manner and location of wear on the tooth surface can be particularly effective in detecting misalignment and identifying its specific type, as elaborated in the analysis section.

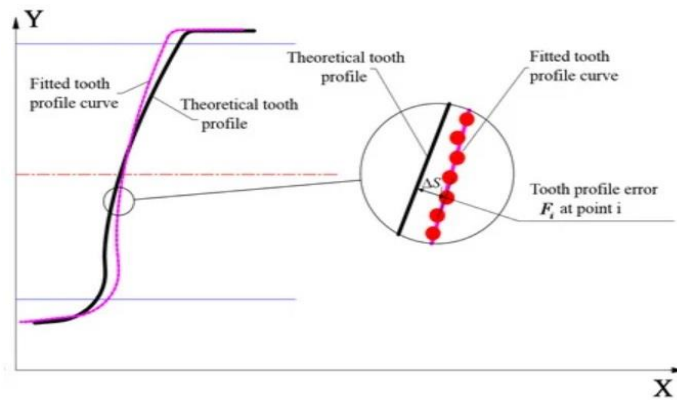
**Tooth Profile Error:** The presence of fluctuating vibrations in the gear and pinion system indicates the existence of a force with variable amplitude. One contributing factor to this variable amplitude force is errors in the tooth profile. A tooth profile error becomes problematic when the manufactured tooth profile deviates significantly from the ideal design state. As illustrated in Figure 7, the black profile represents the ideal and design state, while the purple profile depicts the actual manufactured profile. A tooth profile error can lead to issues such as incorrect backlash or gear meshing problems.

Figure 7. Tooth profile error

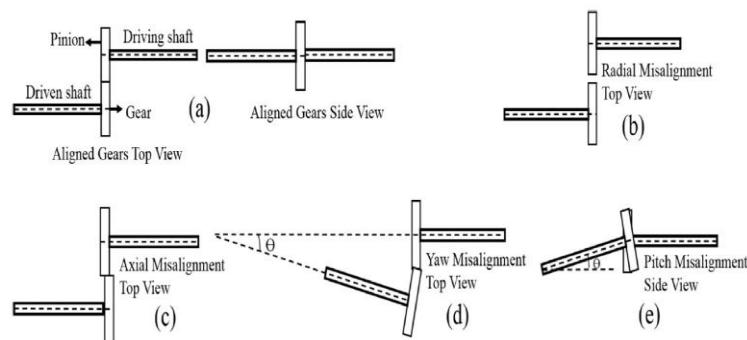
**Radial Misalignment (Mode b):** In this mode, the center distance between the two gear axes is excessive, leading to an increase in backlash, with the contact area primarily in the addendum.

**Axial Misalignment (Mode c):** Here, the center distance corresponds to the correct size, but the two gears have different axial distances. This results in a lack of contact on a portion of the tooth's surface, even though the backlash remains constant.

**Yaw Misalignment (Mode d):** This form of misalignment involves non-parallel orientation of gear shafts, tilted at an angle on the horizontal plane. Yaw misalignment can alter the clearance and backlash, depending on the angle, impacting the contact area and gear noise.

**Pitch Misalignment:** When the pinion and gear shafts are misaligned by introducing an angle in the vertical plane, pitch misalignment occurs. This type of misalignment leads to increased wear on the flank edges, reducing the cushioning effect and causing the gears to impact and separate along the flank edges during meshing.

Figure 8. Five types of misalignment
