The 13th ISAV2023 International Conference on Acoustics and Vibration

Vibration Analysis for Fault Diagnosis in Multi-Stage Centrifugal Pumps: A Case Study at Khatun Abad Copper Complex

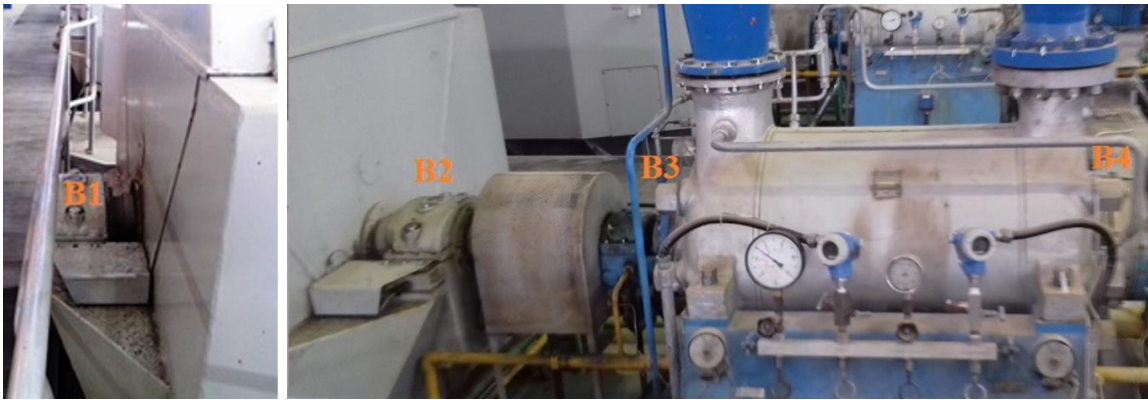
Vibration condition monitoring is a vital technique employed to assess the health status of various industrial equipment. Typically, in industrial settings, vibration condition monitoring is performed according to a predetermined schedule. At the Khatun Abad copper complex, one piece of equipment under examination is the multi-stage centrifugal pump, as illustrated in Fig. 1. This equipment features four bearings, and vibration measurements were taken in three different axes (vertical, horizontal, axial) at four distinct points. To record the pump's vibrations, we utilized the VIBPRO V4- 2 Channels vibrometer (fmax = 40 kHz) in conjunction with the accelerometer vibration probe shown in Fig. 2. Additionally, you can find a summary of the pump's specifications in Table 1. According to the information in Table 1, the described pump is a 7-stage unit with a speed of 2963 rpm (49.3 Hz).

Figure 1. Pump Bearing Positions.

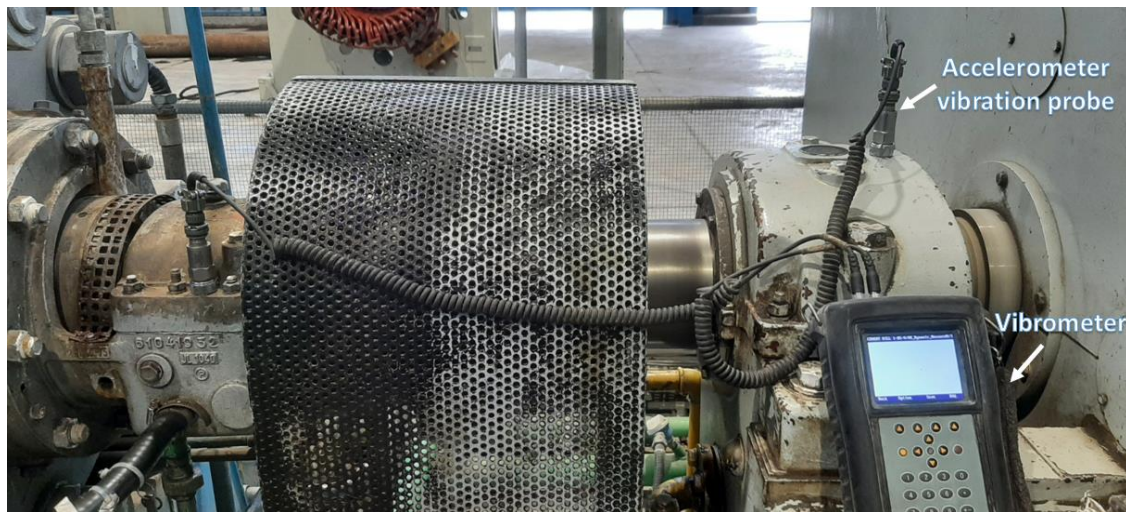
In this study, we perform fault diagnosis on the multi-stage centrifugal pump at the Khatun Abad copper complex using vibration analysis. To accomplish this, we recorded the bearing's vibrations according to a periodic condition monitoring schedule using the VIBPRO V4- 2 Channels (Fmax 40 kHz). This led to the observation of high-amplitude horizontal and vertical vibrations in the third bearing. Finally, we investigate the root cause of the issue and propose necessary actions to rectify the problem.

Figure 2. Test setup.

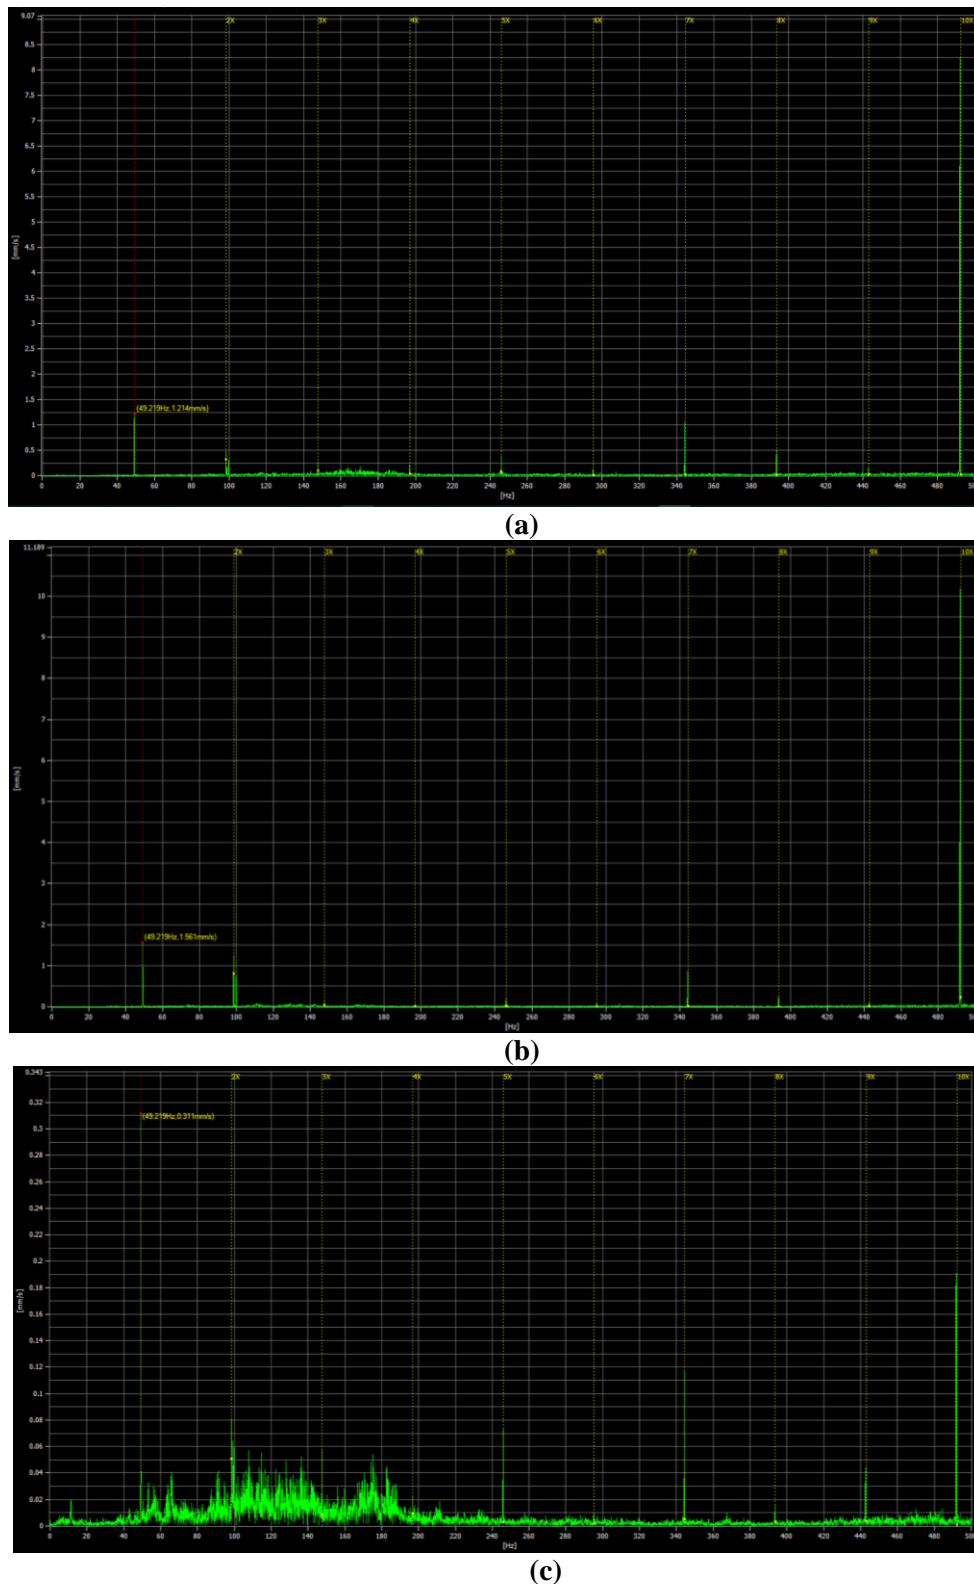
evident that the vertical and horizontal vibration amplitudes for bearing number 3 are exceptionally high. According to ISO 10816-7 standards, the pump falls within the third-class category. Consequently, the allowable vibration value should not exceed 3.5 for the RMS value. To illustrate, the results obtained for bearing number 3 are visualized in Fig. 3. Notably, the tenth harmonic (approximately 491 Hz) displays a prominent amplitude in both the vertical and horizontal directions, with a comparatively lower amplitude in the axial direction of bearing number 3. Additionally, it is worth noting that within this bearing, the most significant vibrations at this frequency are primarily observed in the horizontal direction. Furthermore, the frequency spectrum of the third bearing reveals the presence of the first, second, third, seventh, and tenth harmonics, each exhibiting relatively low amplitudes.

Moreover, the twice-frequency of the tenth harmonic (approximately 491 Hz) is observable in the frequency spectrum of the third bearing across all three directional components. In addition to bearing number 3, the tenth harmonic (approximately 491 Hz) is also evident in all three directional components of the frequency spectrum for the fourth bearing, albeit with a relatively low amplitude. It is worth highlighting that for this bearing, the vertical direction records the highest amplitude for the tenth harmonic.

Additionally, the frequency spectrum of the third bearing also indicates the presence of the first, second, third, seventh, and tenth harmonics, all characterized by relatively low amplitudes. In the frequency spectrum of bearing number 4, both the horizontal and axial directions display the presence of the first, second, sixth, seventh, eighth, and tenth harmonics, each marked by a low amplitude.

Figure 3. Frequency spectrum of bearing No.3; a) vertical; b) horizontal; c) axial.

Following data acquisition and a comparative analysis with data obtained from similar pumps at the Khatun Abad copper complex, it is evident that all aspects observed, including the presence of the tenth harmonic in the frequency spectrum of the other pumps, remain consistent. The primary distinction lies in the amplitude of the tenth harmonic, approximately 491 Hz, which exceeds that of

the other pumps and exceeds the acceptable threshold for this specific pump under study. Considering the recurring presence of the tenth harmonic in all pumps, it can be reasonably concluded that this harmonic is an inherent characteristic of pumps of this type.

However, in the case of the pump under investigation, there may have been alterations that have expanded its vibration spectrum. In multi-stage centrifugal pumps where the impeller blade count differs from that of the diffuser blades, the emergence of harmonics beyond the Blade Passing Frequency (BPF) in the pump's frequency spectrum may result from the interaction between the impeller blades and the diffuser [18], [19]. The amplification of these harmonics can originate from either mechanical or hydrodynamic sources.

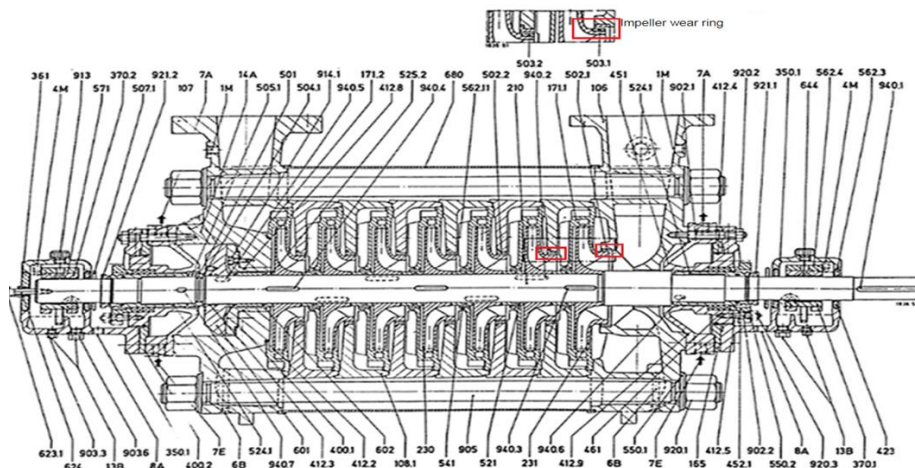
Another mechanical factor to consider is the wear and tear of the casing or impeller wear rings, which can lead to an increase in the clearance between them. Using the pump's catalogue, pump schematic view and the location of casing and impeller wear rings is illustrated in Fig. 4. As it can be seen, the red area signifies the region where the casing and impeller wear rings come into contact. When the gap between these two rings falls within acceptable limits, they effectively function as a journal bearing. However, if either of the two rings becomes damaged or the clearance between them exceeds permissible thresholds, this can give rise to vibrations with significant amplitudes.

Figure 4. Pump schematic and the location of casing and impeller wear rings.

- It is imperative to assess the impact of variations in operational variables, such as flow rate and suction pressure, on the level of vibrations.
- A thorough examination of the impellers and diffusers is essential to identify any signs of corrosion or damage, particularly within the blade area or passages that may be obstructed. If impeller damage is detected, considerations should include replacement or modification and balancing. There is a higher likelihood of damage occurring in impeller or diffuser stages closer to bearing No. 3 due to the elevated vibrations.
- The casing and impeller wear rings should be inspected to assess for any damage and ensure that the gap falls within permissible limits.
