# The 13<sup>th</sup> ISAV2023 International Conference on Acoustics and Vibration

20, 21 Dec 2023      Tehran - Iran

## Vibration Analysis for Fault Diagnosis in an Overflow Ball Mill: A Case Study at Sarcheshmeh Copper Complex

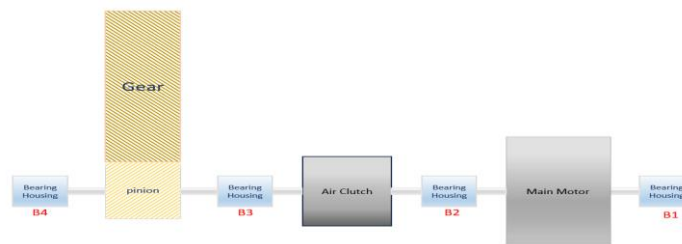
**Figure 1. data measuring points**

The condition of the ball mill is assessed by measuring vibrations on non-rotating components in accordance with the principles outlined in "ISO 10816". As per the standard, measurements are conducted on the four bearing pedestals, as illustrated in Figure 3. Vibration data is recorded in three distinct axes—vertical, horizontal, and axial—for all four bearing pedestals.

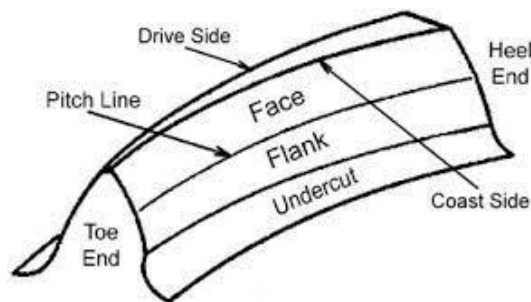
Figure 9. Flank zone in the tooth surface

**Pitch Misalignment:** When the pinion and gear shafts are misaligned by introducing an angle in the vertical plane, pitch misalignment occurs. This type of misalignment leads to increased wear on the flank edges, reducing the cushioning effect and causing the gears to impact and separate along the flank edges during meshing.
